TEST REPORT

No. 20DE-00548-04

Test Specimen: Max 1100

By means of a laboratory simulation, one shipping unit Plastic Case Max 1100 is tested to transport strains. The test specifications are given by the client and are described in the ATA 300 Revision 2008, Cat. 1 standard A [1].

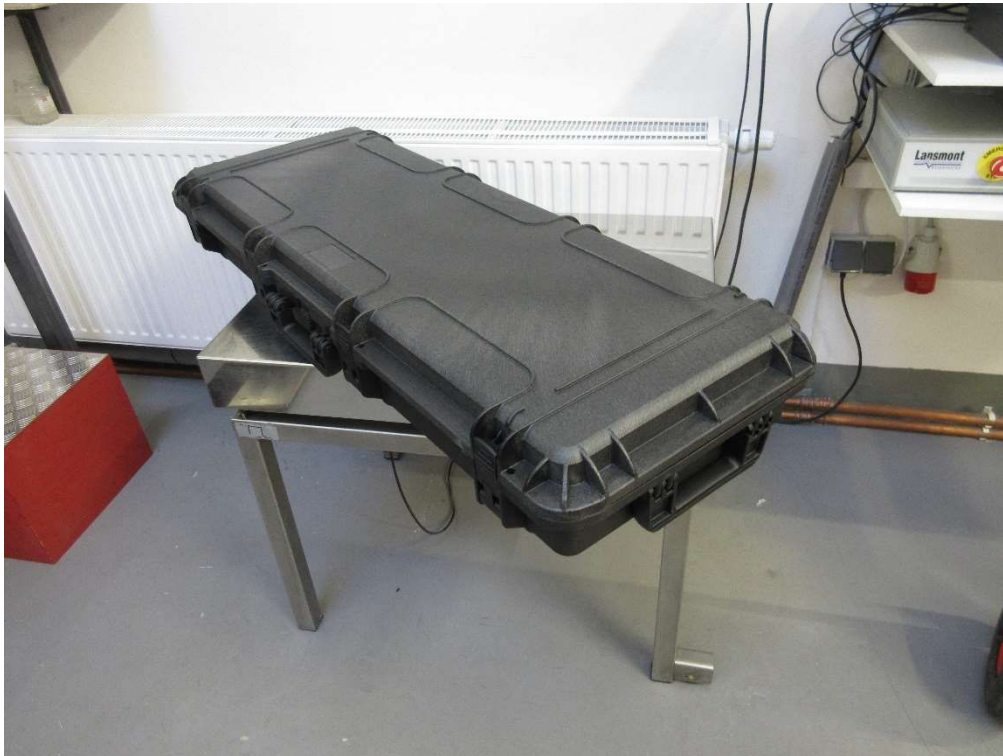
Figure 1: EUT 4

The incoming goods control showed no visible damages at the plastic case.

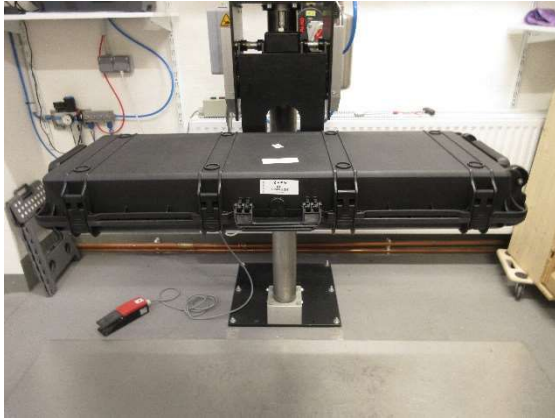
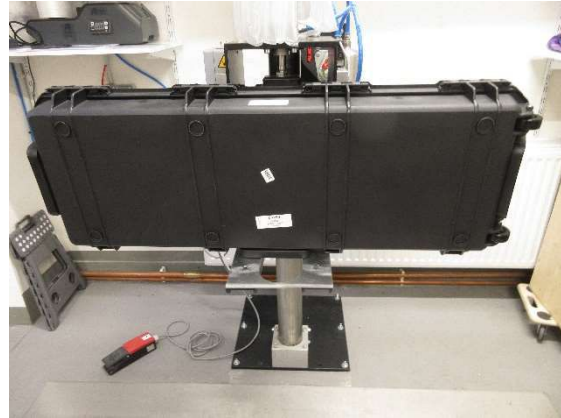
The drops are performed onto a steel plate. Table 5 shows the allocation of the drop number, drop height, and test faces of the shipping unit. Figure 3 to Figure 6 exemplarily shows the test setups.

Figure 3: Setup Drop Tests, exemplarily

Figure 4: Setup Drop Tests, exemplarily

Figure 5: Setup Drop Tests, exemplarily

Figure 6: Setup Drop Tests, exemplarily

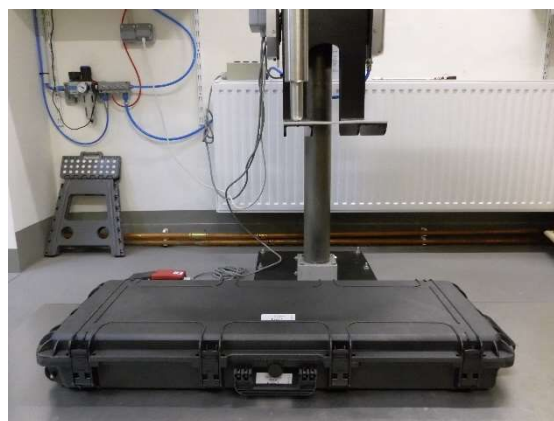
Figure 7: Setup Impact Test

The impact projectile is placed onto the drop table, 50 cm above the top surface of the specimen. A single drop is performed onto the top face. Figure 7 shows the test setup.

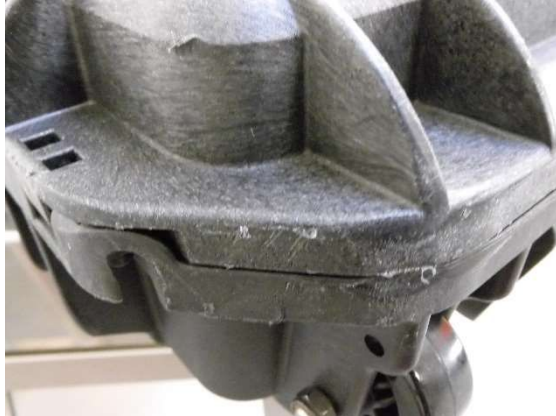
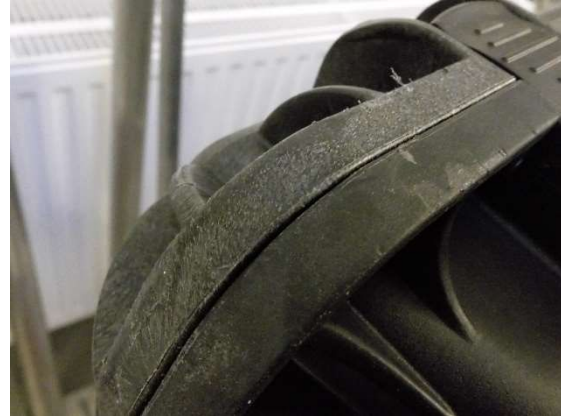
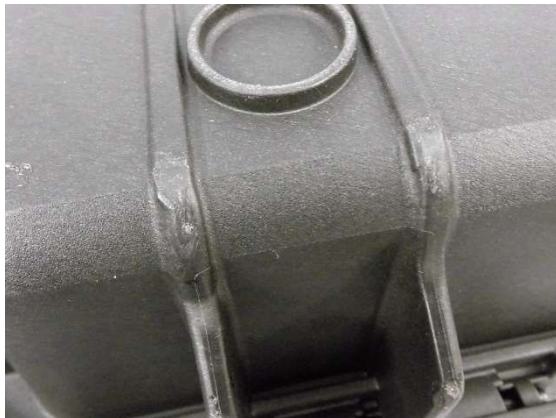
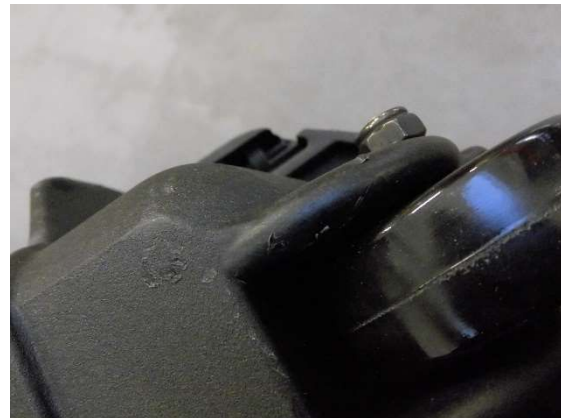
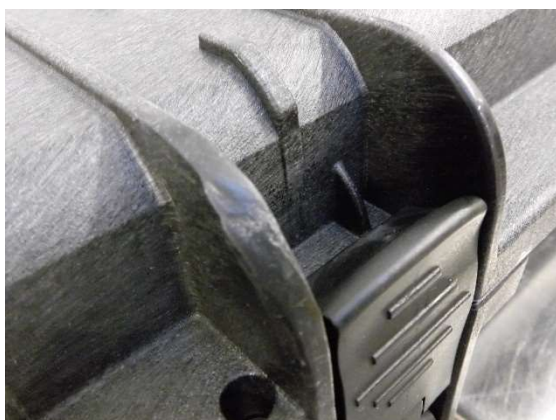
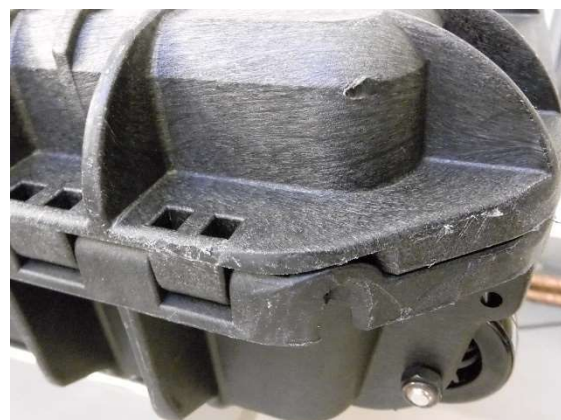
The test was performed according to the parameters specified in Table 2. During the test visible changes were observed. On all edges and corners abrasion could be observed (see exemplarily Figure 8 to Figure 13).

Figure 8: Abrasion, exemplarily

Figure 9: Abrasion, exemplarily

Figure 10: Abrasion, exemplarily

Figure 11: Abrasion, exemplarily

Figure 12: Abrasion, exemplarily

Figure 13: Abrasion, exemplarily

Results Environmental Simulation - Max 1100 -		
Seq	Test	Result Visual Inspection
1	Drop Test	Abrasions on the edges and corners were observed (see Figure 8 to Figure 13)
2	Impact Test	Minor abrasions on the edges were observed (see Figure 14)
