## TEST REPORT No. 20DE-00830

**Test Specimen:** Plastic Case

**Client Reference No:** Max 620H250

By means of a laboratory simulation one Plastic Case Max 620H250 is tested to transport strains. The test specifications are given by the client and are described in ATA 300 Revision 008, Cat. 1 standard [1]

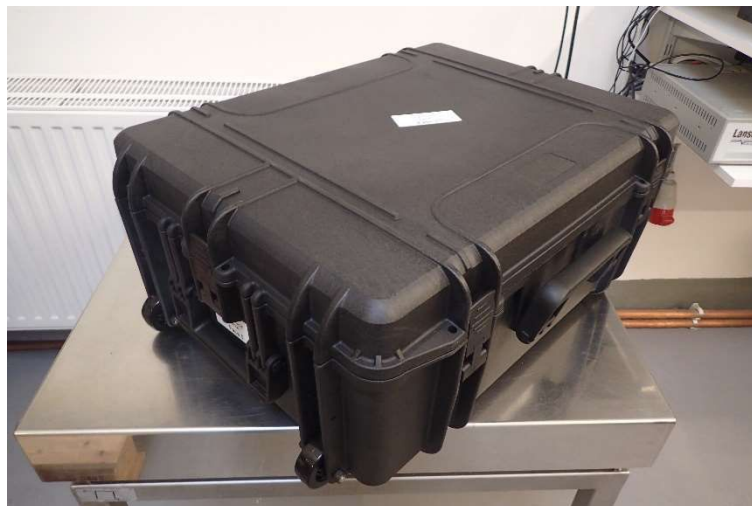
**Figure 1** EUT

For the tests one Plastic Case Max 620H250 (see Figure 1) was provided by the client. Table 1 specifies the shipping unit. In the following designation, the specimen is abbreviated by EUT (Equipment Under Test).

The incoming goods control showed no visible damages at the packaging.

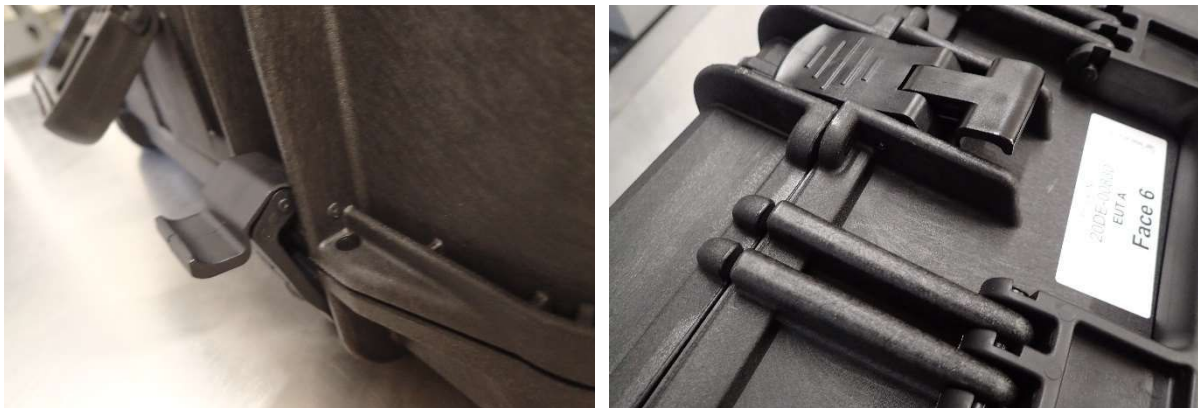
**Figure 5:** Open Latches, exemplarily

All tests were performed according to the test standard. During the tests visible changes could be observed. Single latches unclenched during the drops, but the case in total did not open. After testing drop edges and corners showed abrasion marks and slightly dented bars. However, the interior and exterior of the container did not reveal any failure of functionality.

The test was performed according to the parameters specified in Table 2. During the test visible changes were observed. The latches opened on several drops. Figure 5 exemplarily shows the open latches on edge 1-2. Minor abrasions on the edges/ corners were observed (see exemplarily Figure 6).
