TEST REPORT

No. 20-12865-B

Project Name: Plastic Case Max 800

By means of a laboratory simulation one shipping unit *Plastic Case Max 800* is tested to transport strains. The test specifications are given by the client and are described in the ATA 300 Revision 2008, Cat. 1 standard [1].

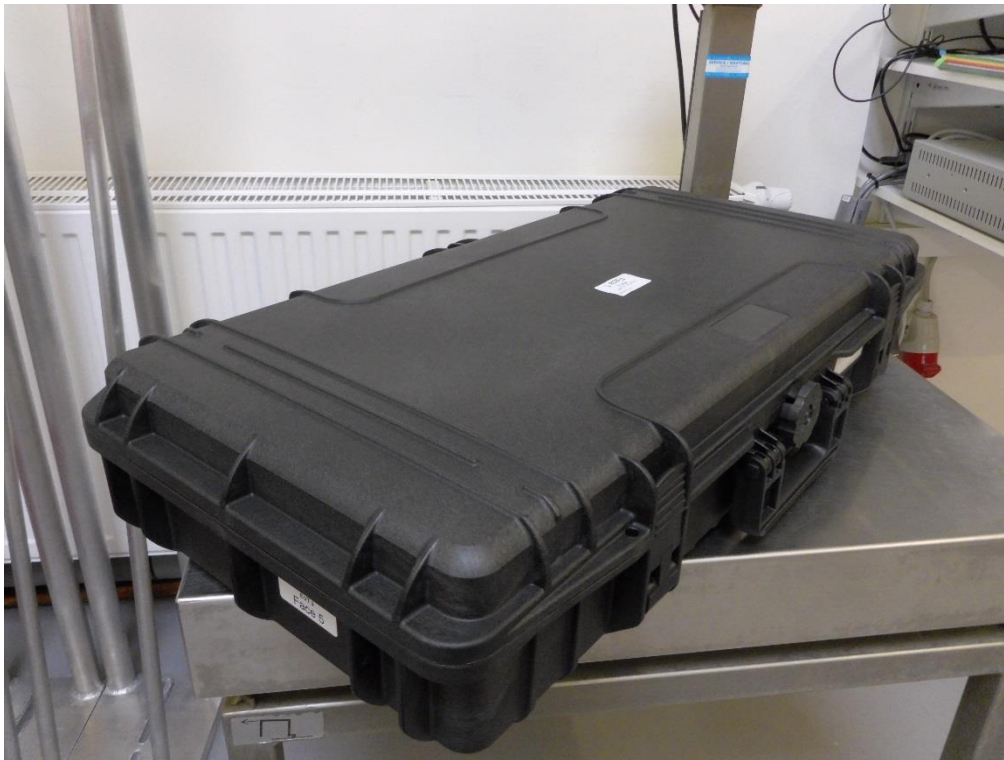
For the tests one shipping unit *Plastic Case Max 800* (see Fig. 1) was provided by the client. Tab. 1 specifies the unit in detail. In the following report the specimen is abbreviated by EUT (Equipment Under Test) and a corresponding number.

Figure 1: EUT 1

The incoming goods control showed no visible damages at the specimen.

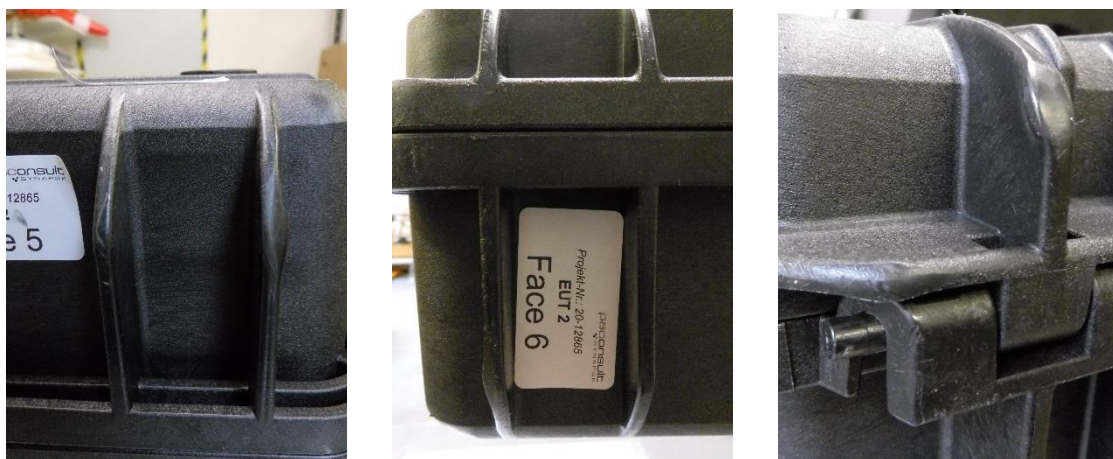
The test was performed according to the parameters specified in Table 2. During the test visible changes were observed. The latches opened on several drops. Figure 5 exemplarily shows the opened latches on edge 1-2. Faces 4, 5 and 6 showed damaged bars and on Face 4 a loosened hinge pin was observed (see Figure 6). On all edges minor abrasion could be observed (see exemplarily Figure 7).

Figure 6: Damaged Bars and Loosened Hinge Pin

- open latches (see Figure 5)
- dented bars and loose hinge pin (see Figure 6)
- minor abrasions (see Figure 7)

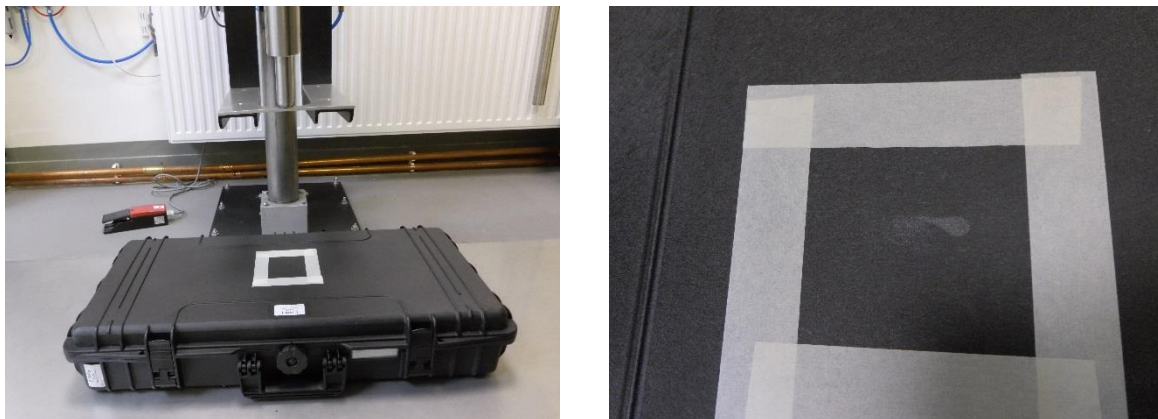
The test was performed, according to the parameters in Table 2. After the test a minor abrasion could be observed (see Figure 8).

Figure 8: Minor Abrasion
